## CENTRAL INTELLIGENCE AGENCY

1 Annex: Rakvere Airfield.

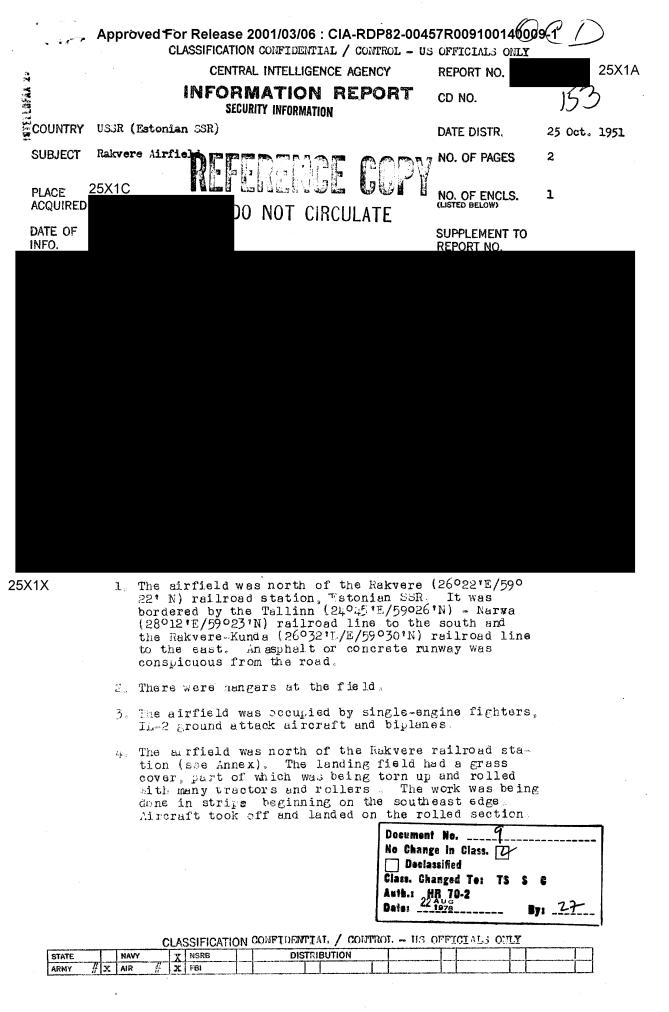
No concrete runways or texiways were seen. Ferforeted steel plates which could be interconnected were piled in front of the hanger on the southern edge of the field. An apron in front of the hanger was covered with such plates.

- 5. A hanger was under reconstruction, its 20 to 25 x 100-meter steel skeleton being completed. Just east of it were destroyed hangers on which no repair work was being done. Five or six centonment buildings, some wooden radio masts and a radio truck were on the western edge of the field.

- 6. There was a fuel dump of two or three dug-in containers, each 10 to 12 meters in diameter and extending by about 2 meters above the ground. It was protected by earth walls, 2 meters high.
